## NMPSIA

### Espanola Public Schools

*Carlos F. Vigil Middle School*

### *Loss Control & Safety Audit*

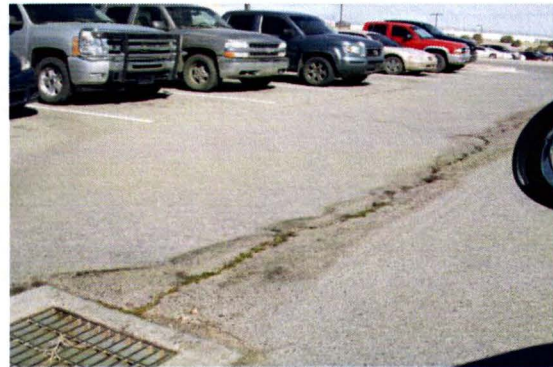
**Recommendation Number: 2014-001**

- Some of the paved areas had minor deterioration that, if left unrepaired, could worsen and result in trip/fall hazards.

- The pavement condition should be closely monitored and repairs made as needed.

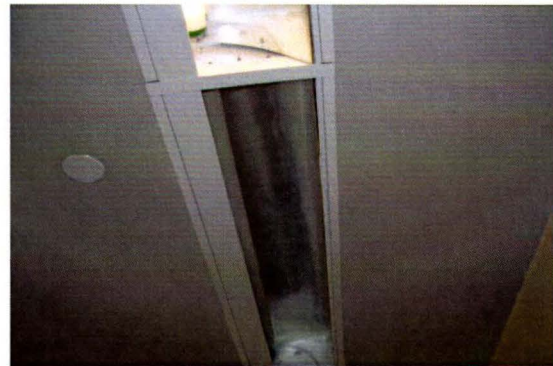
**Recommendation Number: 2014-002**

- The illumination in some areas was dim due to burned out light bulbs.

- The burned out light bulbs should be replaced.

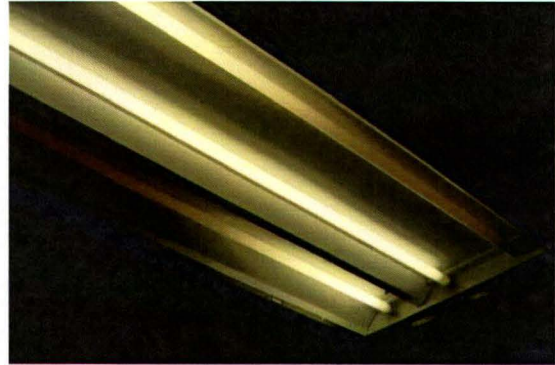
**Recommendation Number: 2014-003****Observations:**

- Some of the light fixtures were missing diffusers.
- Light diffusers reduce glare, protect the light bulbs from damage, and reduce the hazards created by broken glass should bulbs break.

- Missing light diffusers should be replaced.
- Specially designed plastic sleeves may be used in place of light diffusers for fluorescent light bulbs.

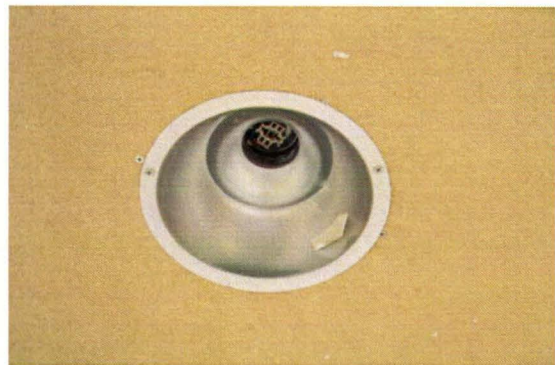
**Recommendation Number: 2014-004****Observations:**

- Exposed light sockets were present where light bulbs were missing.
- The exposed light sockets increase the risks of electric shock and fire incidents.

- Light bulbs should be placed in all open light sockets, or the circuit de-energized, locked and tagged out of service.

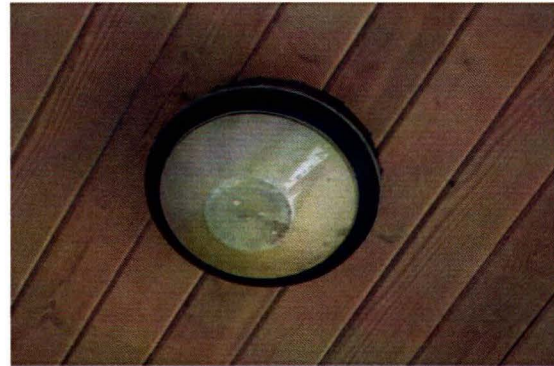
**Recommendation Number: 2014-005****Observations:**

- An accumulation of dirt was visible in the diffusers for some of the overhead lights.
- Some of the light diffusers appeared to be yellowed.

- Dirty light fixtures should be cleaned so that illumination is not impaired.

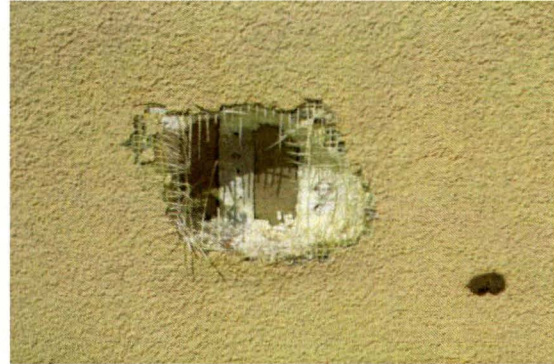
**Recommendation Number: 2014-006**

- The stucco exterior of one or more buildings was damaged.
- The damaged area exposes the building interior structure to the weather elements, and compromises the building's fire safety.

- The damaged areas should be repaired.

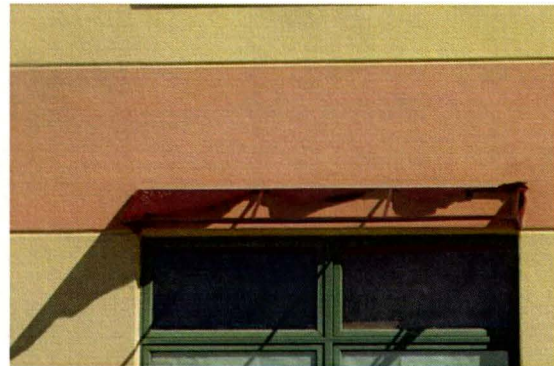
**Recommendation Number: 2014-007**

- Awnings were observed to be damaged.

- Repair or replace as necessary.

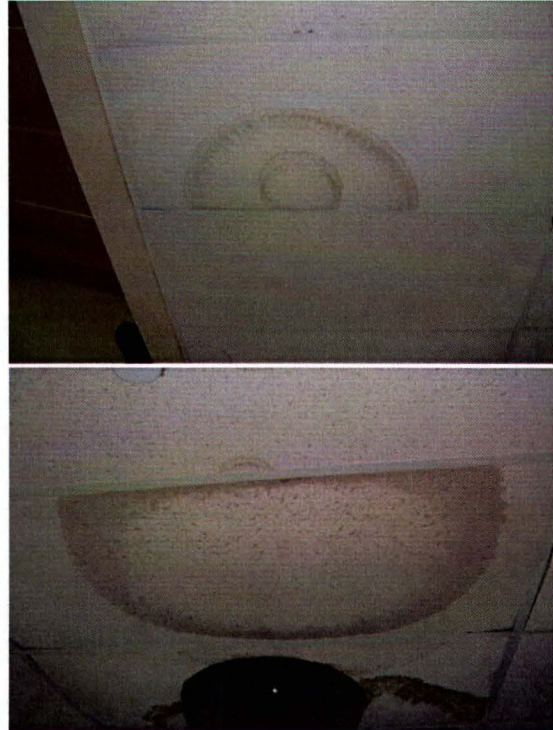
**4. Was the building free of apparent leaks or other obvious water intrusion?****Recommendation Number: 2014-008****Observations:**

- Evidence of leaks and/or other water intrusion was present.
- Water intrusion and the presence of moisture in building materials can foster the growth of mold and mildew.

- The source of the water intrusion should be determined and corrective action taken to prevent recurrence.
- Wall coverings, ceiling tiles, floor coverings, and wall and ceiling insulation should be inspected to identify the presence of damage or mold growth. Both exposed and concealed surfaces should be inspected.
- Damaged and contaminated materials should be removed and disposed of in a way that prevents their continued use.
- The entire damaged or contaminated area should be cleaned and disinfected with an effective fungicide prior to installing new materials.

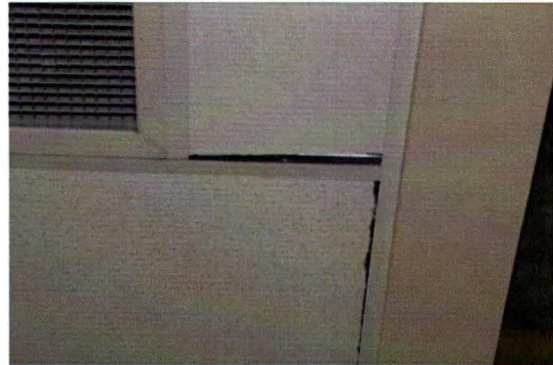
**5. Do walls and ceilings appear to be of an appropriate type and condition?****Recommendation Number: 2014-009****Observations:**

- Loose suspended ceiling tiles were observed.
- These conditions pose falling object hazards that could result in personal injury.

- All suspended ceiling tiles should be properly aligned to help ensure that they do not drop onto furnishings and persons.

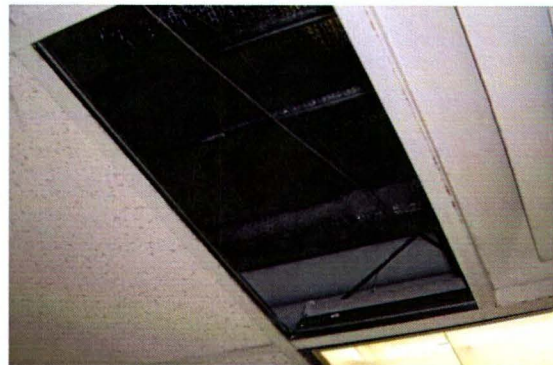
**Recommendation Number: 2014-010****Observations:**

- Some ceiling tiles were missing. The space left by the missing ceiling tile may be adjacent to heat and/or smoke detectors, which could cause the smoke/heat detection system to function improperly.
- Missing ceiling tiles compromise building fire safety and pose an attractive nuisance.

- Missing ceiling tiles should be replaced and maintained in place.

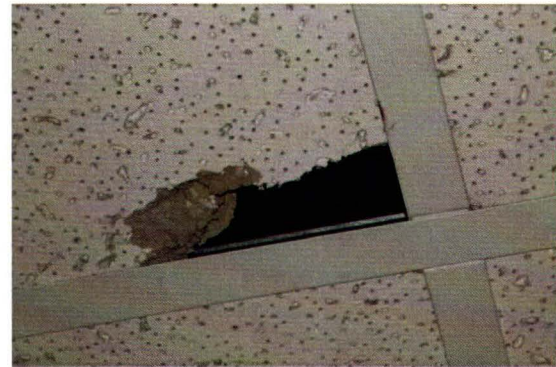
**Recommendation Number: 2014-011****Observations:**

- Holes were observed in some of the ceilings.
- The holes compromise the fire safety of the structure, and they provide an entry point for insects and vermin.

- The holes should be sealed.

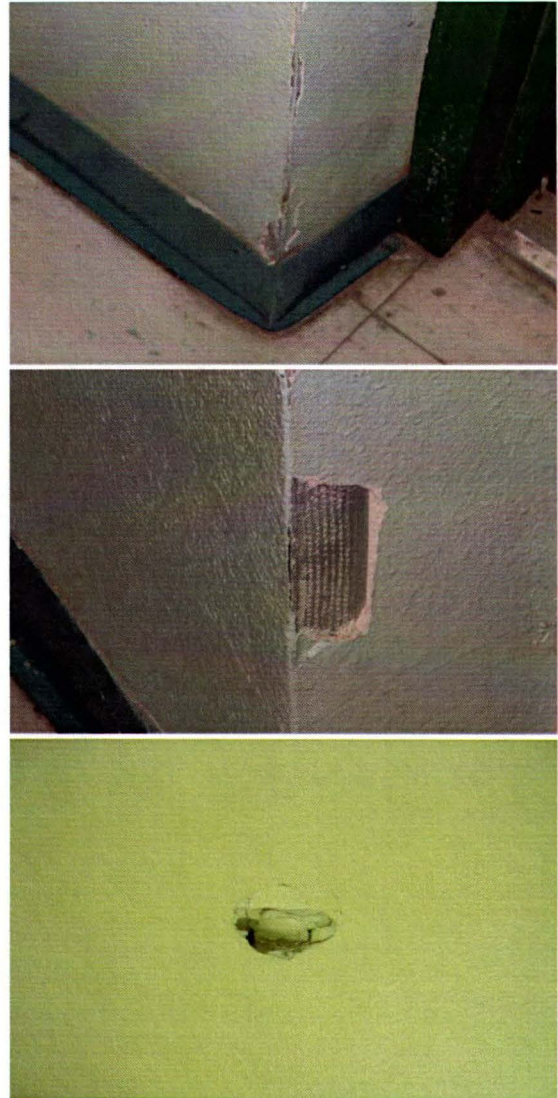
**Recommendation Number: 2014-012****Observations:**

- The wall covering observed in one or more areas was damaged and/or peeling.
- The damaged areas pose an attractive nuisance and invite more damage.

- Any damage to the walls or wall coverings should be repaired.

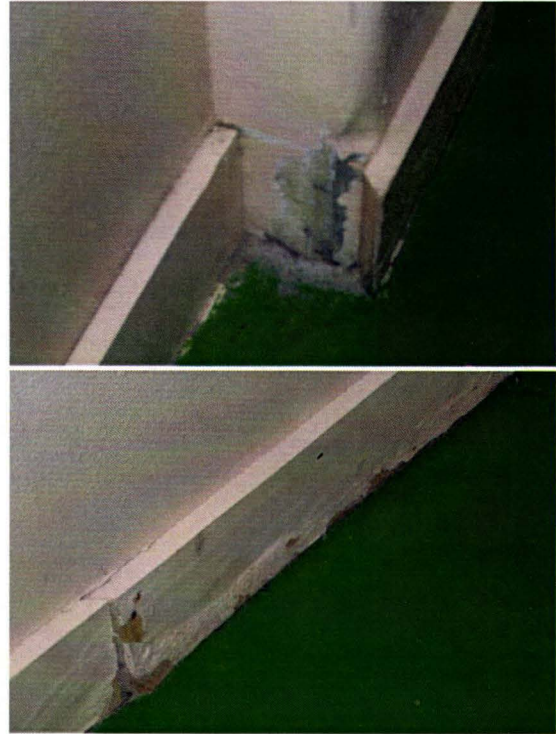
**Recommendation Number: 2014-013****Observations:**

- Some of the baseboard molding observed was damaged or missing.
- This condition poses trip/fall hazards.

- Damaged or missing molding should be repaired or replaced as necessary.

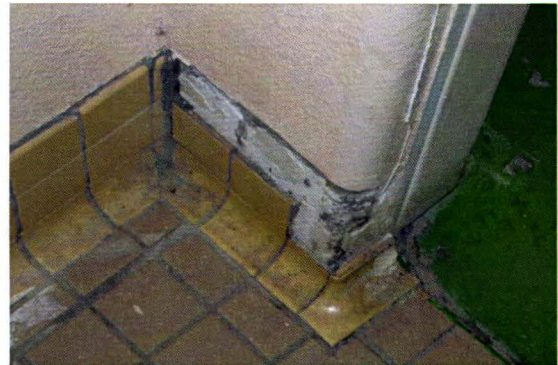
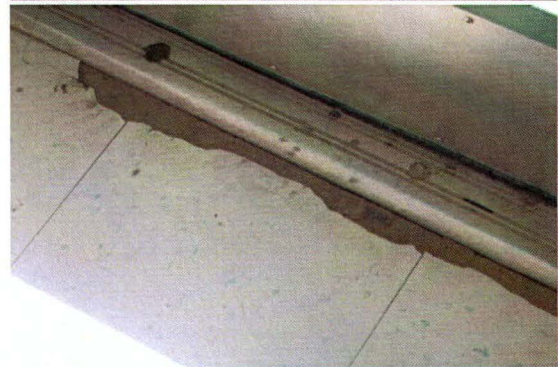
**6. Are floors and floor coverings of an appropriate type and condition?****Recommendation Number: 2014-014****Observations:**

- Some of the floor tiles were damaged.
- Some of the damaged floor tiles or their adhesive may contain asbestos, which could present an asbestos exposure hazard.

- The site Asbestos Management Plan should be reviewed to determine if the flooring contains asbestos.
- Damaged flooring that does not contain asbestos should be removed and replaced.
- Damaged flooring that contains asbestos should be abated in accordance with AHERA requirements.
- Missing and damaged floor tiles should be repaired and/or replaced to reduce trip/fall hazards.

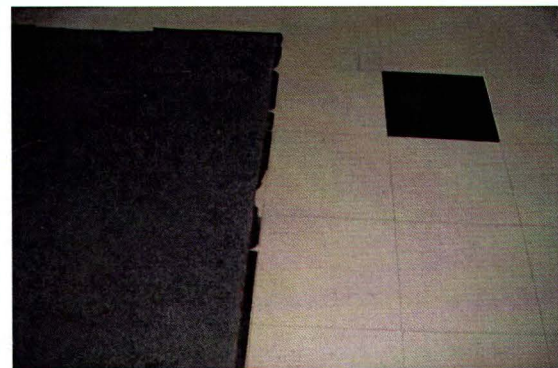
**Recommendation Number: 2014-015****Observations:**

- Some of the doormats were torn, curled, and/or damaged. This condition poses trip/fall hazards.

- Damaged or curled doormats should be replaced with heavy-duty commercial doormats equipped with nonslip backing.

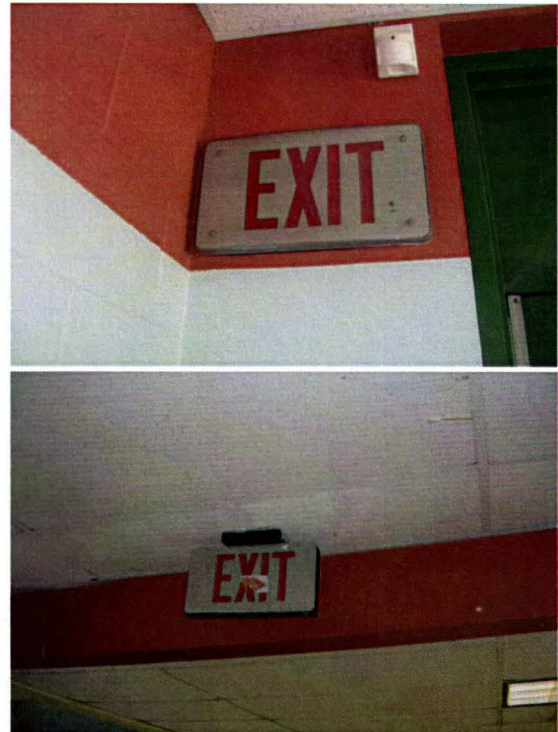
**Recommendation Number: 2014-016**

- One or more of the illuminated exit signs were not illuminated; therefore, we could not determine if they were fully functional.

- The exit signs should be activated to determine if they are fully functional.
- Exit signs should be provided with bulbs for all sockets so that the signs are still illuminated even if one bulb fails.
- Exit signs should be inspected on a regular basis to ensure that they are functional at all times.

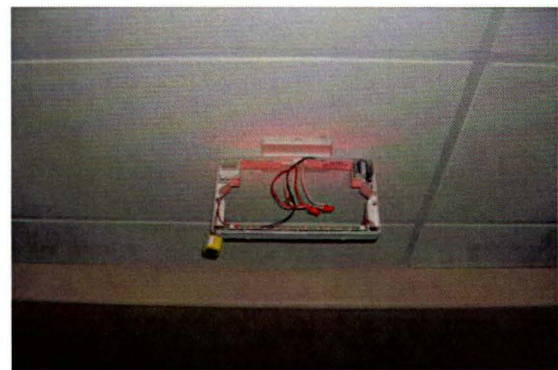
**Recommendation Number: 2014-017**

- Some exit signs were damaged and/or broken.

- Damaged exit signs should be repaired.
- Exit signs should be provided with bulbs for all sockets, so that the signs are still illuminated even if one bulb fails.
- Illuminated exit signs should be installed above exits to ensure that exit routes are properly identified.
- Illuminated exit signs should be properly installed.

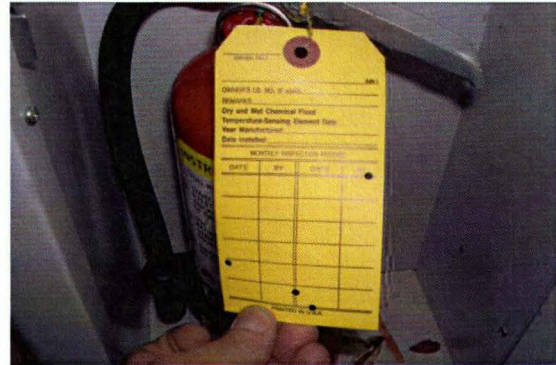
**Recommendation Number: 2014-018**

- Monthly fire extinguisher inspections are not being conducted.

- The fire extinguishers should be inspected on a monthly basis to ensure that:
  - they are properly wall mounted;
  - the seals and pull pins are still intact; and
  - the units are fully charged and ready for use.
- The monthly inspection should be documented with the inspector's initials on the back of the annual inspection tag.

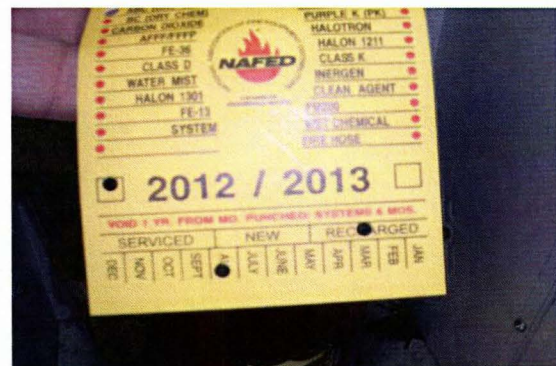
**Recommendation Number: 2014-019**

- One or more fire extinguishers were not serviced during the last annual service.

- The units that were not inspected should be replaced with fully charged and recently inspected fire extinguishers.
- Consideration should be given to numbering each fire extinguisher location and developing a map to show each fire extinguisher location to reduce the potential for overlooking one of the fire extinguishers during the servicing process.
- In addition, the annual fire extinguisher service provider should be required to annually change the color of the inspection tags. The difference in tag color would increase the ease of identifying overlooked fire extinguishers.

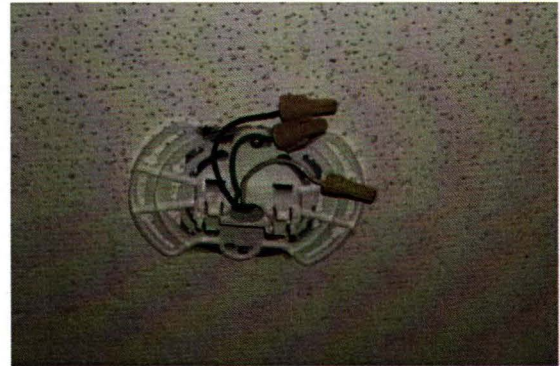
**Recommendation Number: 2014-020**

- A smoke/heat detector was missing.

- Replace missing detectors as necessary.

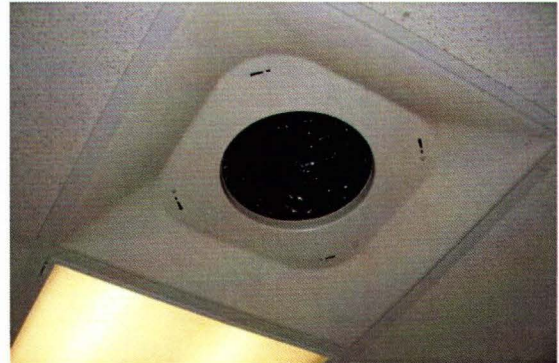
**Recommendation Number: 2014-021**

- Some ventilation grills were missing.
- Missing vent covers or register grills pose an attractive nuisance. In addition, conditioned air is not properly directed or diffused.

- Missing vent covers or register grills should be replaced.

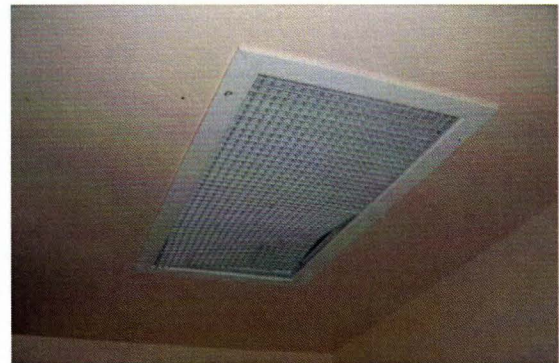
**Recommendation Number: 2014-022**

- Some ventilation grills were damaged.
- Damaged vent covers or register grills pose an attractive nuisance. In addition, conditioned air is not properly directed or diffused.

- Damaged vent covers or register grills should be replaced.

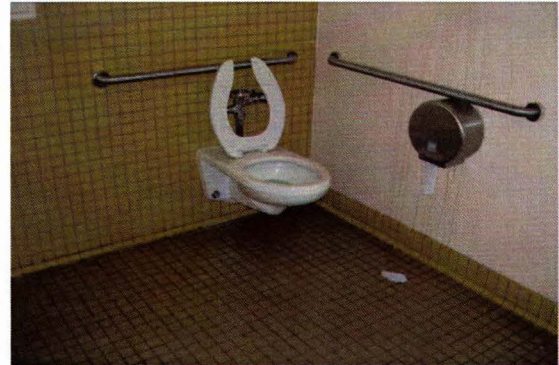
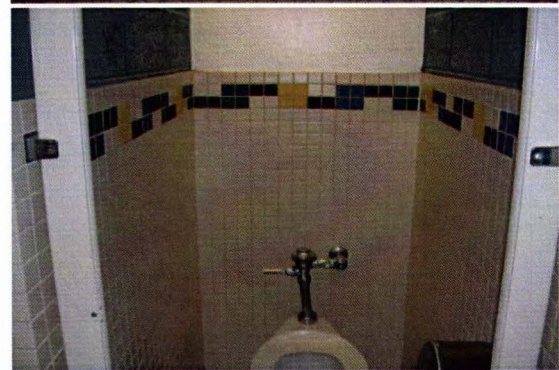
**Recommendation Number: 2014-023**

- Some restroom stalls were missing doors.

- Replace restroom stall doors as necessary.

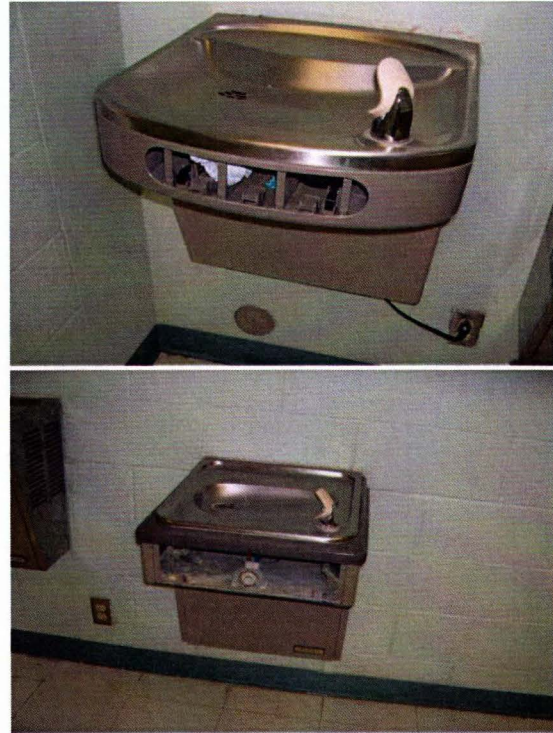
**Recommendation Number: 2014-024****Observations:**

- One or more of the drinking fountains were broken and inoperative.

- Broken drinking fountains should be repaired or replaced as necessary.

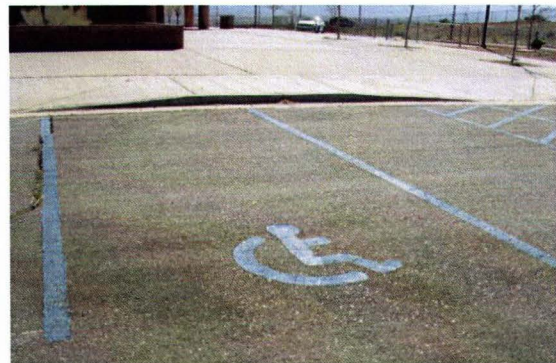
**Disabled Access****12. Are an appropriate number of parking spaces designated for disabled persons, and are they properly designed, constructed, and signed?****Recommendation Number: 2014-025****Observations:**

- The required elevated signs designating accessible parking spaces were not provided.

- The required elevated, accessible parking signs should be provided. The signs may be post-mounted or mounted to a building or fence.

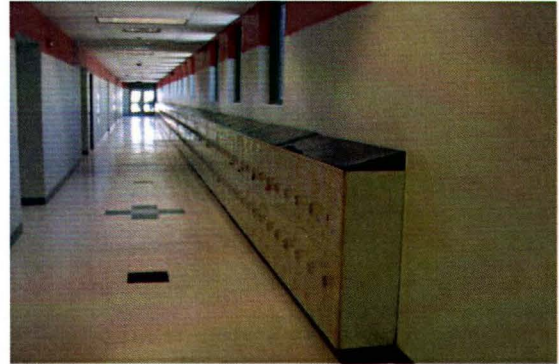
**Recommendation Number: 2014-026**

- Student lockers were present but not in use. Eliminating student lockers may reduce vandalism, contraband, and harassment incidents.

- Consideration should be given to removing the lockers.
- If the District chooses to retain the lockers, any damaged lockers should be repaired or replaced.
- If lockers are retained and used, they should be assigned by grade level to reduce the likelihood of harassment between grade levels.

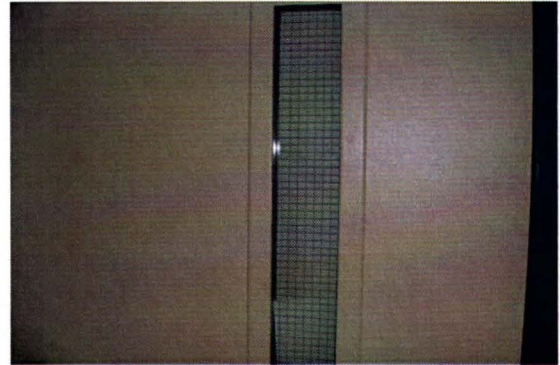
**Recommendation Number: 2014-027**

- Paper was observed over the windows of the classroom doors.
- This practice compromises the security of the room's occupants and violates the requirement to keep doors free of decorations.

- This practice should be discontinued.
- No paper or combustible items should be placed on the door.
- The windows in the doors should be kept unobstructed to help reduce the risk of collision between persons using the doors from opposite sides and to ensure that the security of the rooms can be viewed from the hall.

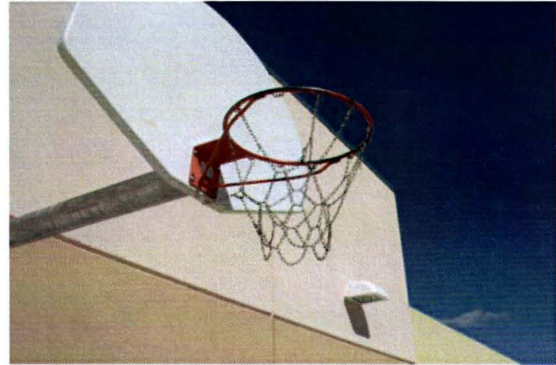
**Recommendation Number: 2014-028**

- Metal chain basketball nets were in use.  
These nets pose an increased risk of injury.

- The chain nets should be removed and replaced with linen or nylon fabric nets or the hoops left without nets.
